# **Narrow cross sections without centre line markings – “2 minus 1” rural road**

## **Road user behaviour study Summary Note**

June 2007

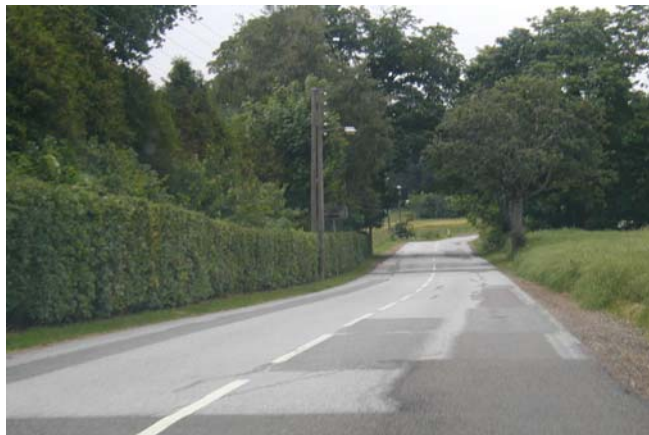
*Figure 1: Before situation. Two lane rural road with centre line marking*

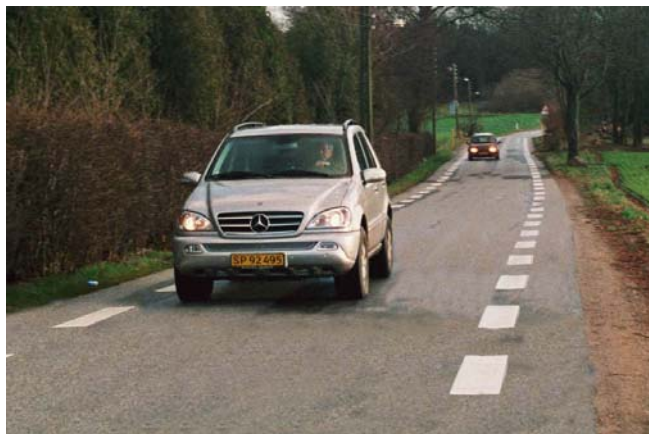
*Figure 2: After situation. One central driving lane*

In the new "2-1"- profile the centre line marking has been deleted. The redesigned road have only one central driving lane – 3.5m width – marked by 0.30m wide intermittent edge lines leaving an area of 0,85m width in both sides for cyclists and for cars to use in meeting situations (Figure 2)

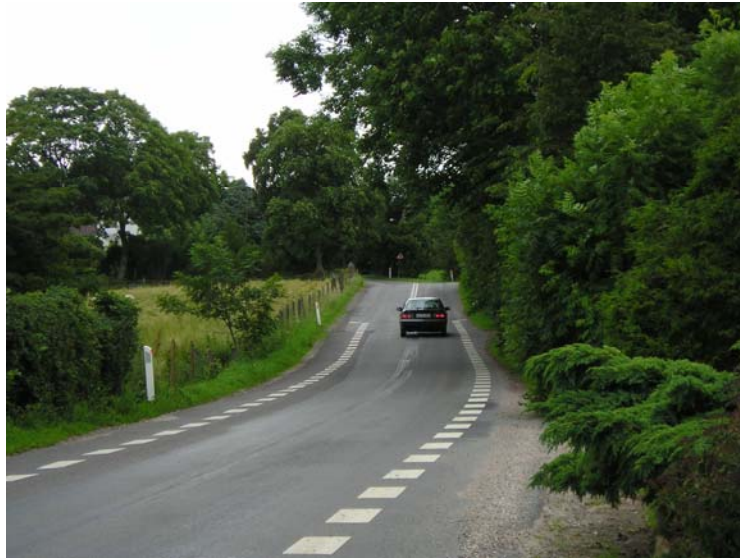
In curves where stop sight distance is too short for the "2-1"-solution the profile has remained as a two lane rural road with centre line marking (Figure 3).

Figure3: Centre line marking is remained in curves when "stop sight distance" is too short.

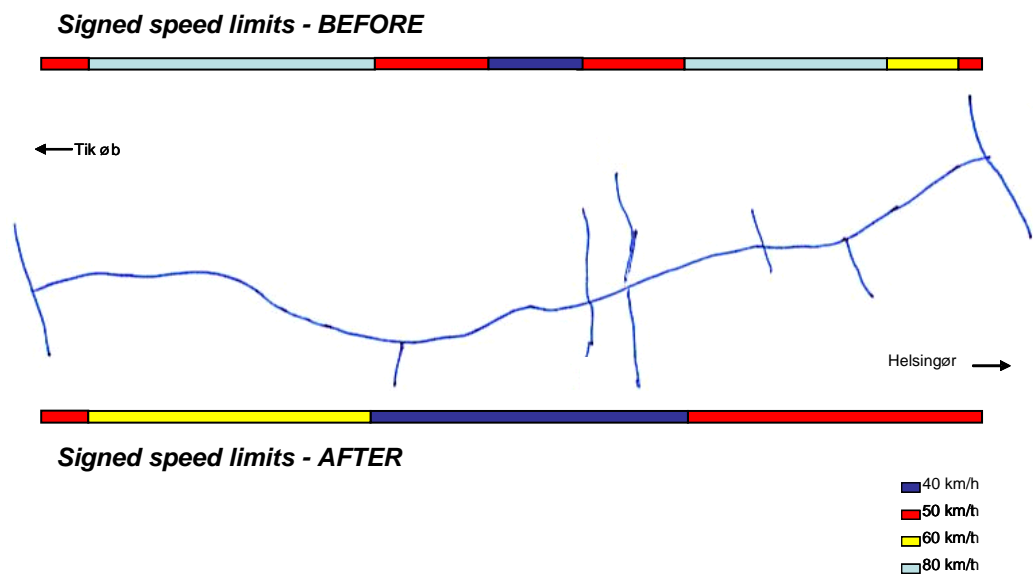
**Edge lines are related to signed speed limit**

The length and spacing of the intermittent edge lines are longer the higher speed limit:

Signed speed limit	Length of spacing
60 km/h	2m – 2m – 2m – 2m -
50 km/h	1m – 1m – 1m - 1m -
40 km/h	½ m - ½ m - ½ m - ½ m -

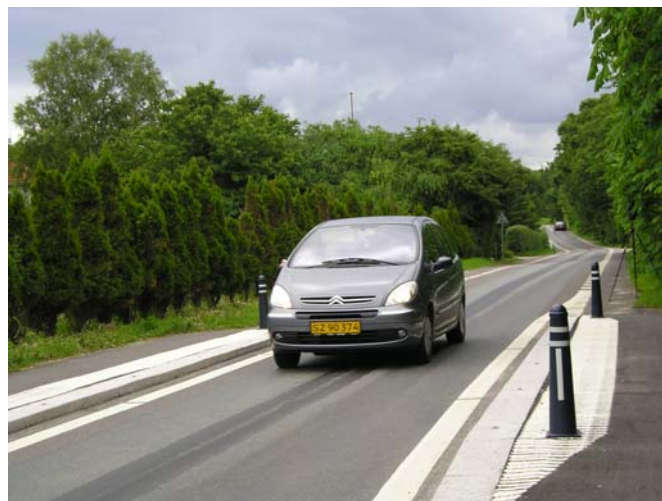
The new "2-1"- profile is supplemented by 12 speed reducers - designed as 16 m long narrowings edged by side islands (see Figure 4).

*Figure 4: Speed reducer*

- Mostly the meeting situations at speed reducers are handled without problems. The drivers seem to interact and adapt speed when approaching a narrowing letting the first arrival pass first. Problems are observed though in 5-10 % of the observed situations. It is not always quite clear to the drivers who should be the first to pass the narrowing. (see figure 4). In some cases both drivers stop and wait for each other to pass. In other cases one of the drivers continue without slowing down "forcing" the on-coming driver to give way. Accidents are observed in the narrowed speed reducers because of this confusion among drivers. A simple solution to this minor problem could be a sign telling the drivers who should go first.

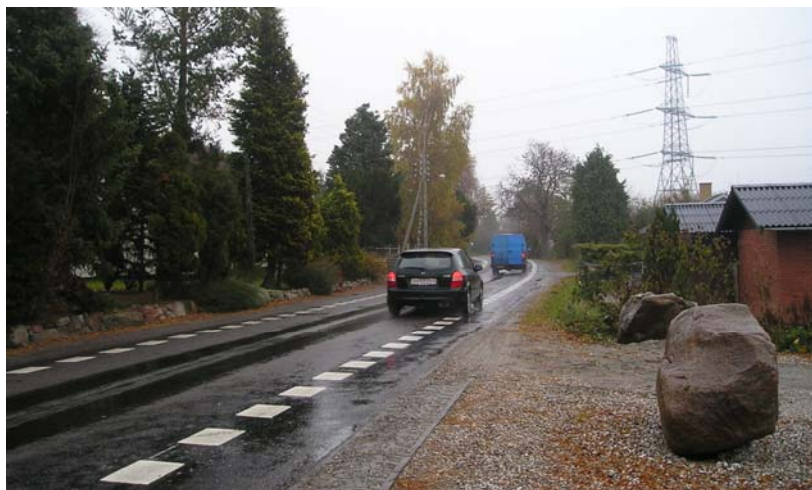
Figure 5: In meeting situations drivers give way to on-coming cars by crossing the intermittent edge line a little bit as intended.

- The drivers seem to behave as intended in meeting situations on road sections. Drivers give way to the on-coming drivers by changing the lateral position to the right and in some cases the right wheels are crossing the intermittent edge line a little bit as intended. On-coming traffic pass in both directions without problems even though the "2 minus 1" road has only one central driving lane (see figure 5)
